Co-analysis for the Mariakerke (Belgium) nourishment site

Sebastian Dan¹ and Daphne Thoon²

¹*Flanders Hydraulics Research, Berchemlei 113-115, 2140 Antwerp, Belgium*

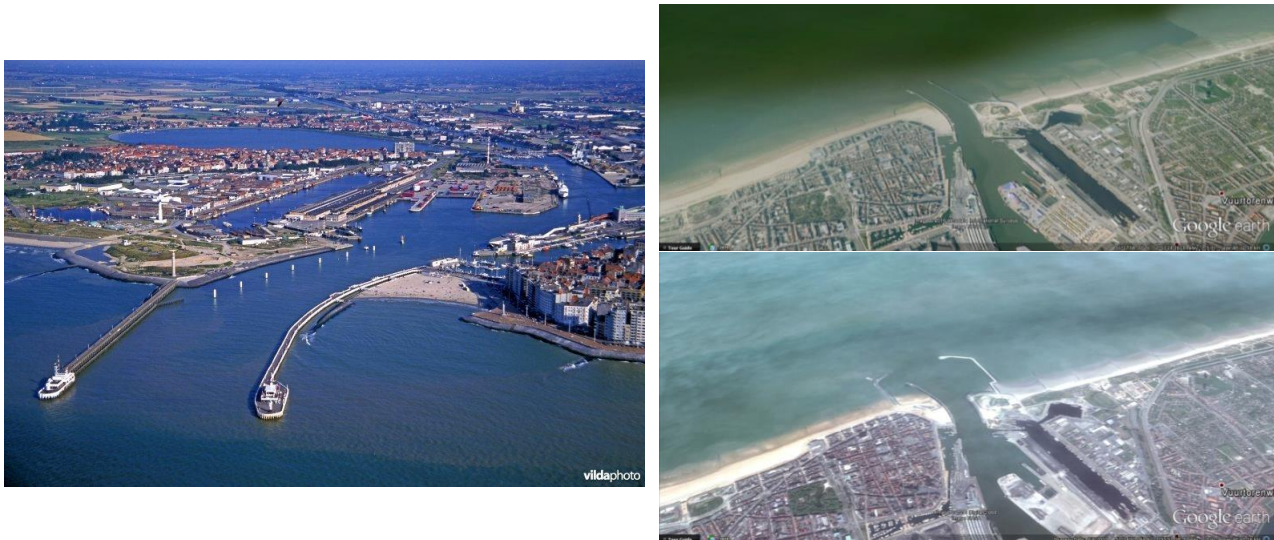
Figure 1 – Ostend harbor overview before 2004 (INSHORE, left), in 2007 (GoogleEarth, right top) and in 2011 (GoogleEarth, right bottom).

Long jetties extend over more than 500 m distance from the coast in order to protect the entrance to the harbor (Figure 1 –). The stretch of coast within a 5 km radius from Ostend is characterized by a sandy shore with visible cross-shore hard structures (groins), spaced 200 – 500 m alongshore. The largest part of Ostend city develops west of the harbor jetties. The eastern part consists of a wide system of dunes that connects Ostend to De Haan and few nourishments occurred in this part.

Before 2004, the beach in Ostend center consisted of a narrow strip in low tide and no beach at all at high tide. The emergency nourishment raised the beach profile, so that at high tide, a strip of about 200 m of dry beach was created. The nourishment took place between April and June 2004. The median grain size before nourishment was about 0.2mm and after nourishment 0.3-0.35mm, locally up to 0.4mm (Bertels *et al.*, 2012).

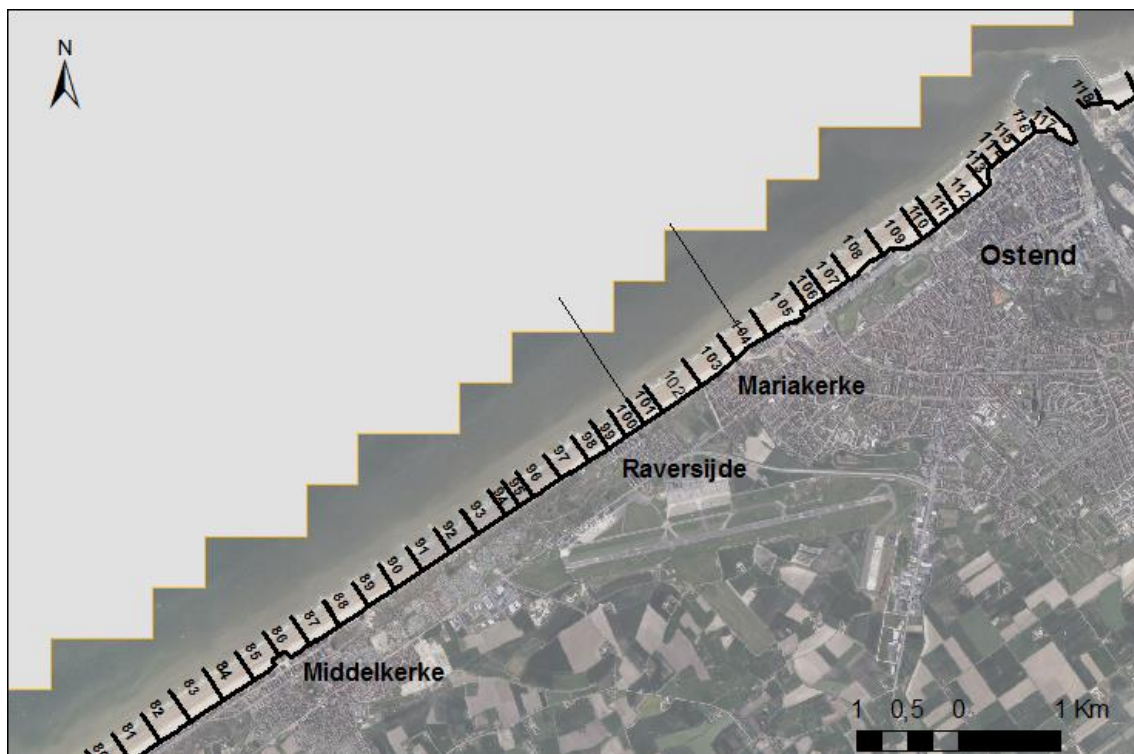
Figure 2 – Coastal sections at Raversijde-east and Mariakerke (pilot site) and nearby coastal areas.

The pilot nourishment was in three steps during year 2014 at Raversijde-east and Mariakerke area sections 97 to 108, using sand extracted from the sea (locations of the coastal sections in Figure 2). Before the nourishment experiment numerous smaller nourishments took place in the study zone in order to maintain the coastal safety. The nourishments from 2008 to 2011 are presented in Table 1.

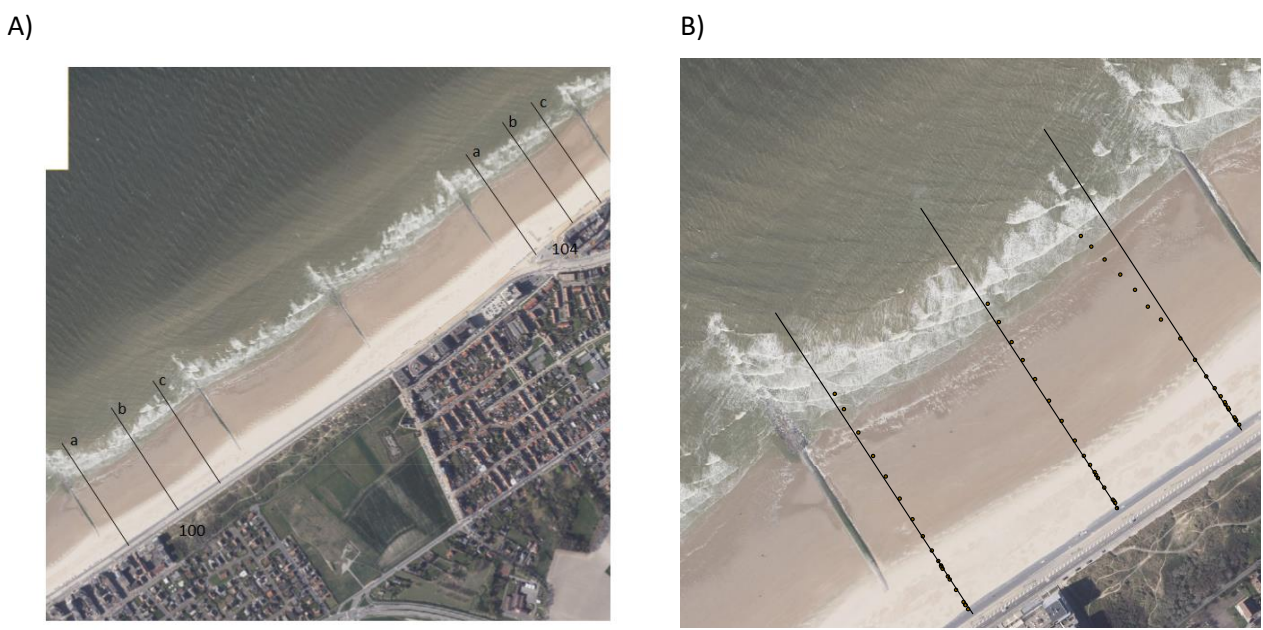
Figure 6 – A) Map of the location of the cross-shore profiles at reference sections 100 and 104; B) Example of observed shift of a profile.

Three cross-shore profiles have been carried out at both section 100 at Raversijde-East and section 104 at Mariakerke every month between September 2015 and December 2018 (Figure 6A). Extra surveys were done before the storms of 14/01/2016 and 12/01/2017; and after the storms on 18/01/2016 (extended just until 110 m seaward) and 16/01/2017. Also beach was surveyed twice in March 2017 but none in October 2016 and November 2017 and during the summer season from July to August. A RTK-GPS system was used in walking mode. The distance interval between profiles is around 150 m and extend from the dyke to 300 m towards the sea. The measurements were not accurately following the profile, therefore the points were projected on the designed profile.

A shift (deviation from the straight line) up to 26 m was observed between cross-shore profiles located at the same position due to walking survey error (Figure 6B). Therefore a correction was applied by re-projecting all the profiles using referenced profiles in ArcGIS environment. Then, the indicators such as intertidal width and slope of the intertidal beach and the dry beach were extracted from the re-projected, interpolated profiles. The references to calculate the intertidal beach width (intertidal beach slope are the MLWL and MHWL; and the MHWL and the sea dyke for the dry beach width (dry beach slope).

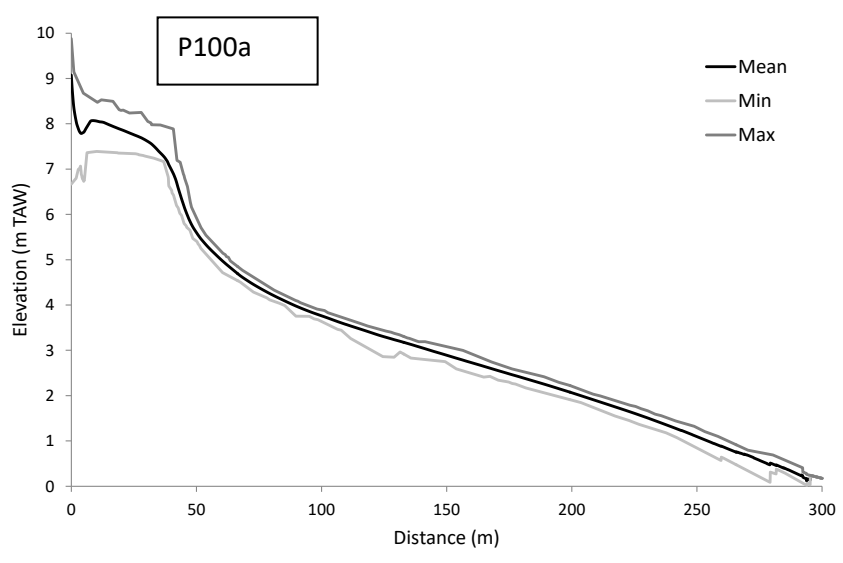
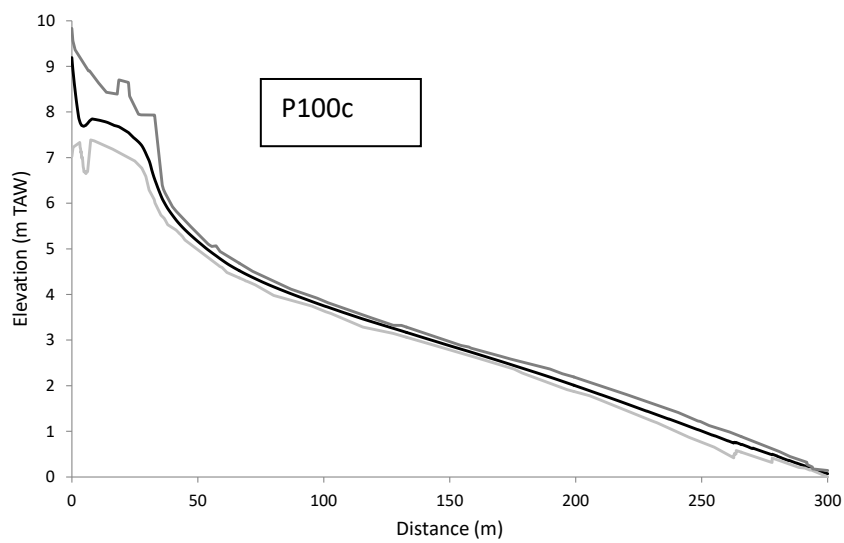
Figure 7 – Envelope of the cross-shore profiles for section P100 (a, b, c) at Raversijde-East from September 2015 to December 2017.

Figure 7 and Figure 8 show the envelope of the three re-projected cross-shore profiles for section 100 (a,b,c) at Raversijde-East and section 104 (a,b,c) at Mariakerke from September 2015 to December 2017. Both sections indicate the presence of a berm of the dry beach above +7.0 m TAW while the intertidal beach is with featureless and a gentle slope. The greatest elevation variability is found on the upper beach at a distance of less than 50 m from the dyke while the changes of the intertidal beach are usually minor (except

for profile P104a and P104b). Thus, a spatial and temporal variability of the elevation is observed at a monthly scale. As expected at location 104 where more both types of nourishments were performed the variations are larger than at location 100.

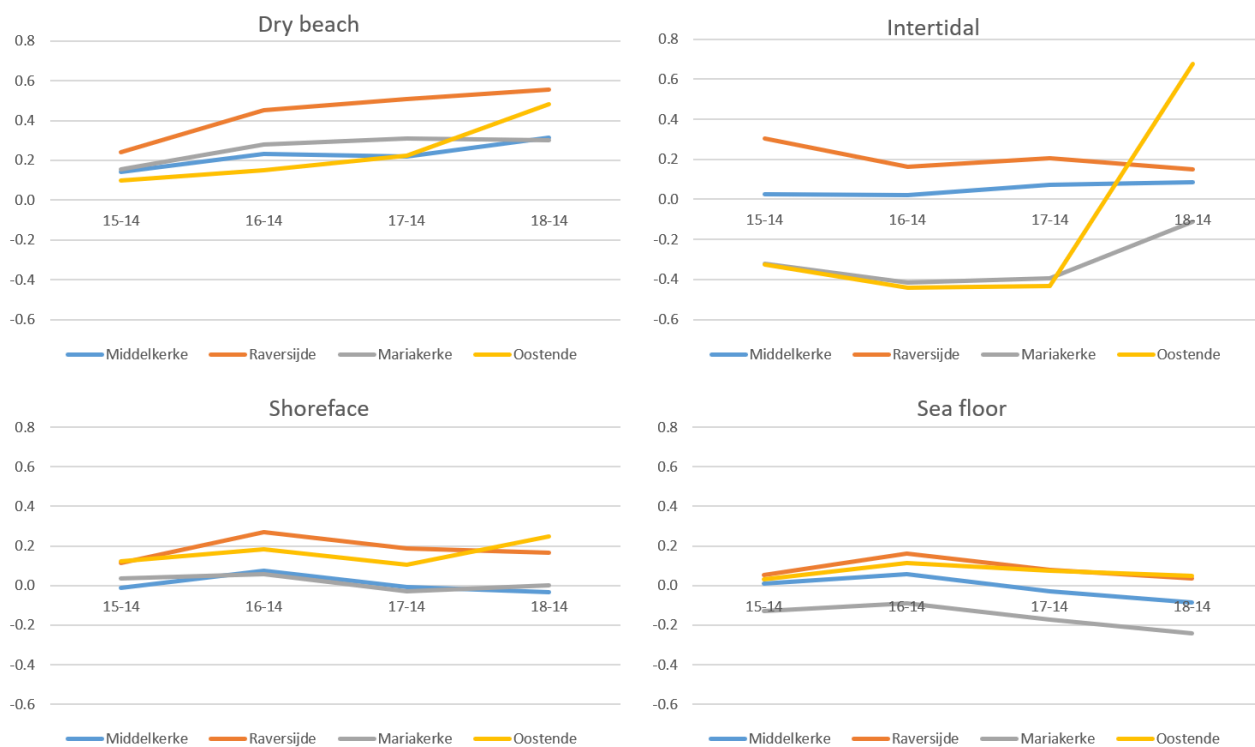
Figure 22 - Evolution of the four beach parts having as reference the post-nourishment situation.

The shoreface and sea floor sectors display a very similar evolution, with a gain in volume in the first two years and loss in the last year. Probably, the sand lost from this area can be found close to the port jetty accumulating further seaward, outside of the study area as it was defined before the nourishment experiment. The extension of Oostende port was performed relatively recent, in 2011, therefore the accommodation space created here is still to be filled out in the next years, as these jetties are impermeable to the alongshore sediment transport. However, accumulation against the jetties created a shallow area which make possible the transfer of sediments outside of the study zone (Figure 21 and Figure 22).

The intertidal beach show consistent evolution with rapid initial volume decrease due to the fact that the majority of the beach nourishment was placed in this area, so easier to erode in the initial stage. However, in the later years this area start to accumulate sand, most probably as results of human interventions (local redistribution of sand, additional nourishments). Although at slower pace, the dry beach volume increased in the three years of its post-nourishment evolution, mostly due to the aeolian transport (Figure 21 and Figure 22).

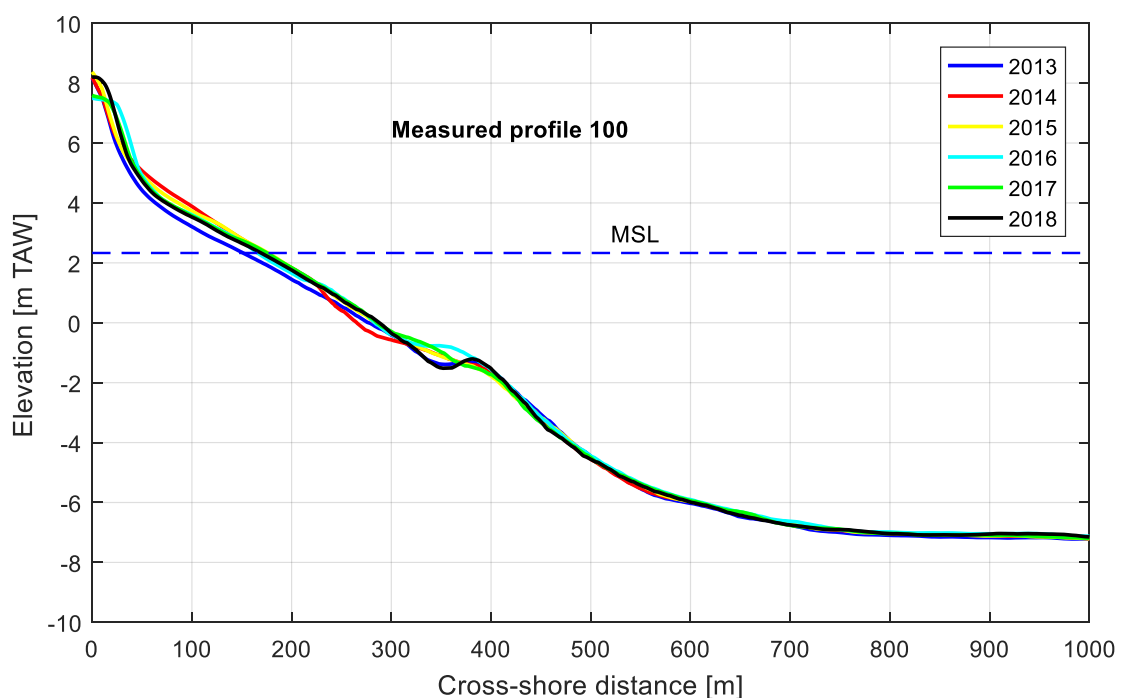
Figure 26 – Evolution of the cross-shore profile at [Raversijde](#): profile 100

The changes of the profile 100 located in Raversijde (middle of the section) are also analyzed (Figure 26). This profile represents for the coastal area where only beach nourishment was carried out (in June 2014). Note in this analysis that the topo-bathymetry of the beach in the Raversijde area for 2014 was conducted in November (i.e. five months after beach nourishment campaign in June 2014). Compared to the profile in 2013, the one in 2014 moved seaward due to the beach nourishment in June 2014. The changes are much smaller than that for the Mariakerke case. This is mainly due to the fact that the amount of nourished sand is smaller for Raversijde and the topography used in the analysis is measured much longer after conducting beach nourishment for Raversijde than for Mariakerke.
