**FILTER SYSTEMS FOR A  
SUSTAINABLE AGRICULTURE**

# FIELD CASE DESCRIPTION

Phosphorus filter box  
for drainage water at Anzegem

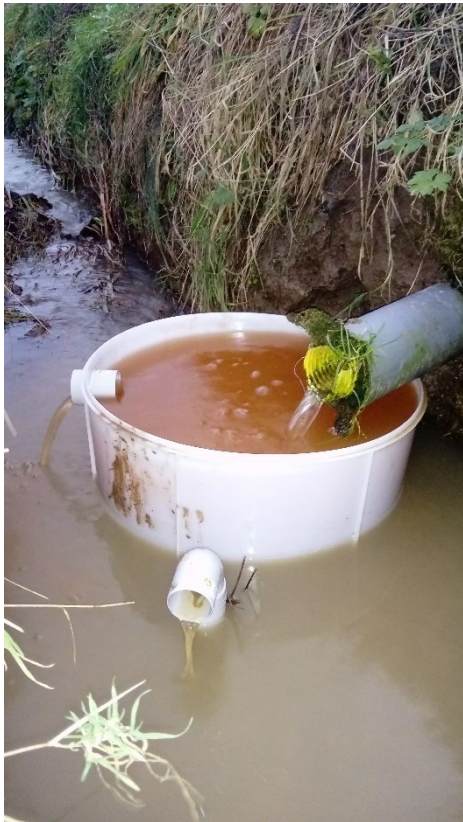
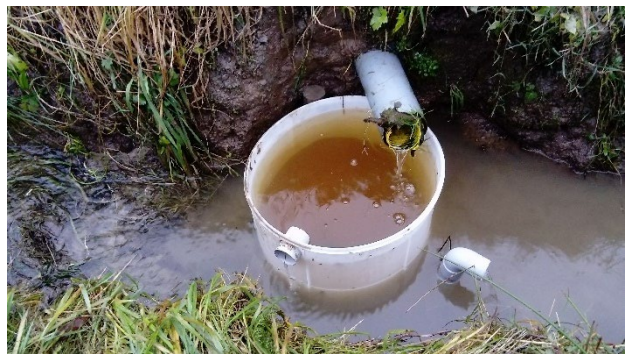
*Figure 3 the custom-made filter ton in the season of 2017-2018 and 2018-2019*

One cylindric custom-made filter ton was installed in December 2017 (Figure 3) filled with iron coated sand (ICS). Filter materials were filled a layer of no more than 20 cm (approximately 32 l). A layer of wire mesh of 0.75 mm was placed on the bottom to stop big particles. Water enters the filter directly from the top of the ton and the height difference between the outlet tube and the top was 5 cm.

The same filter ton was used but the ICS was renewed as there was a lot of sediment/soil/algae in the filter. The filter box was cleaned and refilled with fresh sieved ICS.

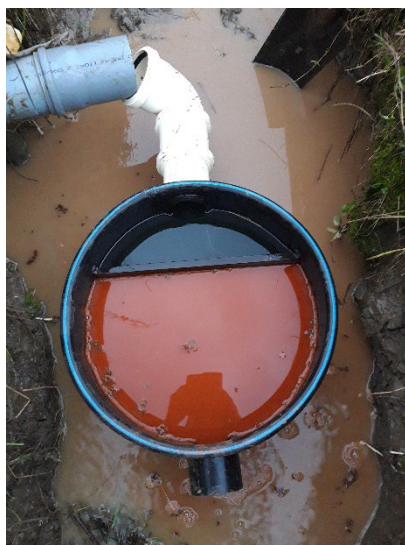
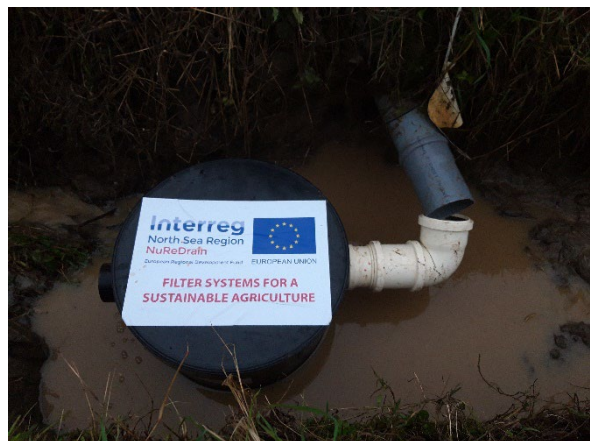
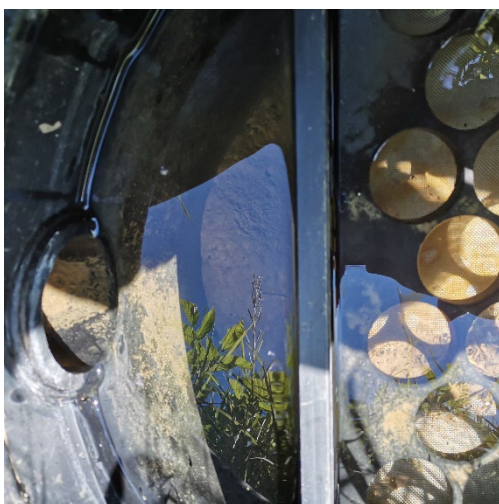
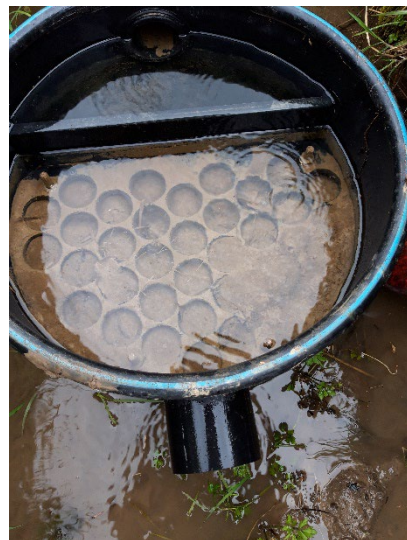
Figure 4 Prototype installed in the season of 2019-2020 and 2020-2021

The new prototype filter (cylindric shape, Figure 4) was installed in December 2019 with sieved filter materials (ICS>2mm). A layer of 24 cm with approximately 35 l of ICS was filled in the filters.

The prototype from season 2019-2020 was kept until March 2021 to check the long-term performance of the filter. From January 2021, overflow was observed and the filter was gradually clogged by sediment as shown in Figure 4, not only at the bottom but also at the top of the filter.

After two seasons, the P removal efficiency of the prototype filter decreased gradually: on average 39% and 27% of total P (TP) and 34% and 12% of dissolve reactive P (DRP) was removed in the first and second season, respectively (Figure 8). As seen in Figure 4, the filter box was clogged in the season of 2020-2021 and this could be one of the reason to explain the low P removal efficiency.
